Summary Report
Visual Inspection of the Uxbridge Brook Culvert
Town of Uxbridge

March 2nd and 3rd 2009

Engineered Management Systems Inc.

Confined space entry inspection conducted by
Soderholm Maritime Services

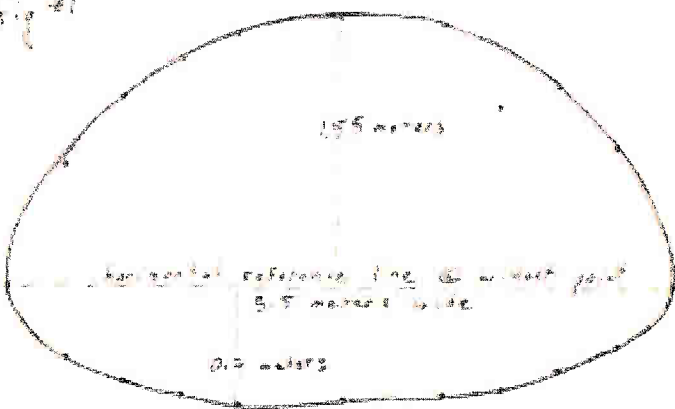
| station in meters | station in feet | video ref | description | photo no |
|---|---|---|---|---|
| 6 | 20 | 0:02:00 | <p>profile of arched culvert</p> <p>profile of arch culvert shown on east side, west side typical</p> | 3 |

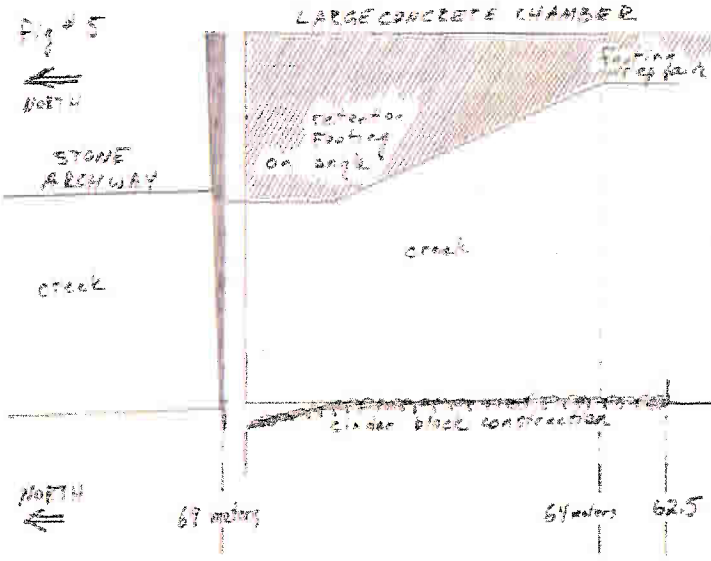
| station in meters | station in feet | video ref | description | photo no |
|---|---|---|---|---|
| | | | <p>top view of chamber from 62 to 69 meters</p> | |

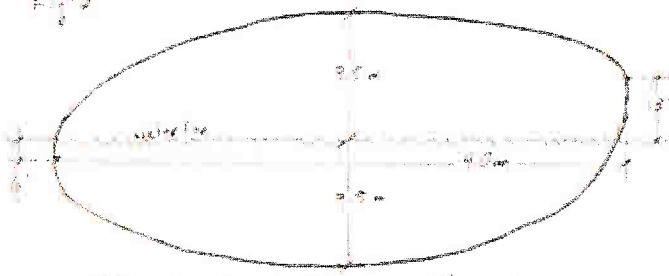
| station in meters | station in feet | video ref | description | photo no |
|---|---|---|---|---|
| 140 | 459 | | <p>CSP culvert is 4.0 meters wide by 1.9 meters high at this location, most flattened out location. the 0300 position (east widest point) is 18" above the water line, and the 0900 position (west widest point) is 6" below the water line</p> <p><i>profile drawing of culvert at this chainage</i></p> <p><i>profile of culvert (looking north) at chainage 459 meters</i></p> | |

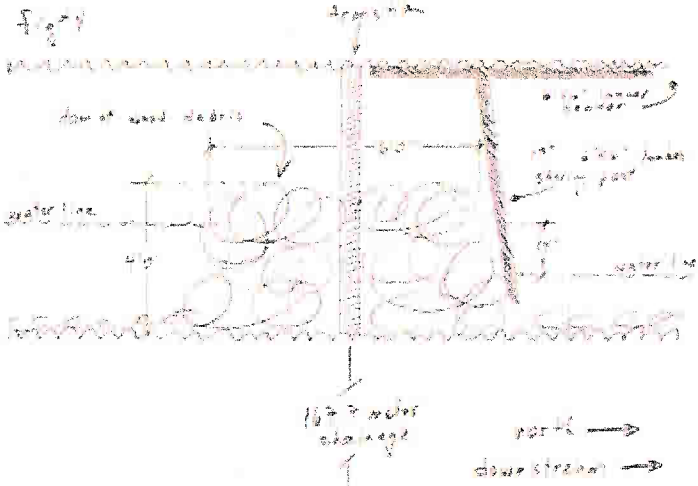
This section of culvert is shored by 6 vertical 6"X 6" wooden posts. Currently, only the 1st shoring post is weight bearing from the ceiling, and the cause of the dam of debris. The other 5 shoring posts are not functional. The dam of debris is holding back 36 cm of water elevation differential.

| station in meters | station in feet | video ref | description | photo no |
|---|---|---|---|---|
| | | 2:02:40 | <p>dam is 4' high, 6' deep, and the width of the culvert, water differential from one side of the dam to the other is 14"</p> <p><i>at this point in the video log we switch to the second recording tape</i></p> <p><i>profile drawing of dam and shoring posts</i></p> | |

Install shoring below Sections 3 and 4. This will also be far easier to achieve after the aforementioned removals. Removal of any blockages arising from the shoring acting as an obstacle should be monitored on a weekly basis by municipal staff. Note - at this point in time shoring of these Sections has not been recommended only because of the potential for blockage and the difficulty in monitoring it and remedying it.

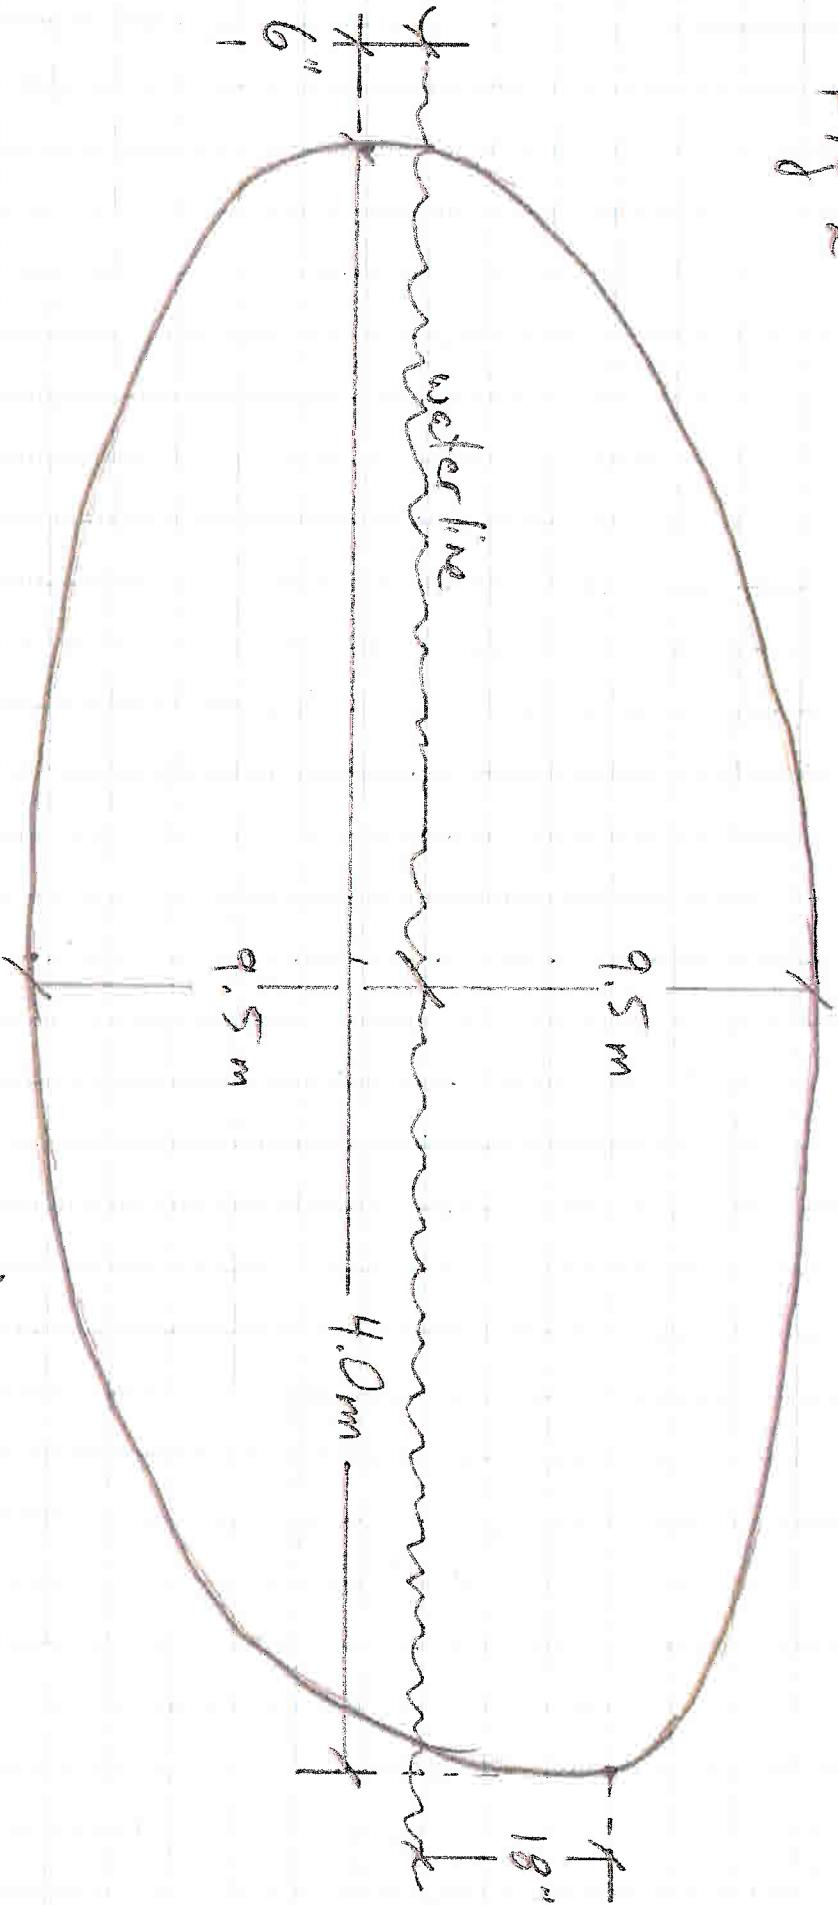
Fig#2

Profile of culvert (facing north) at
chainage 459 meters

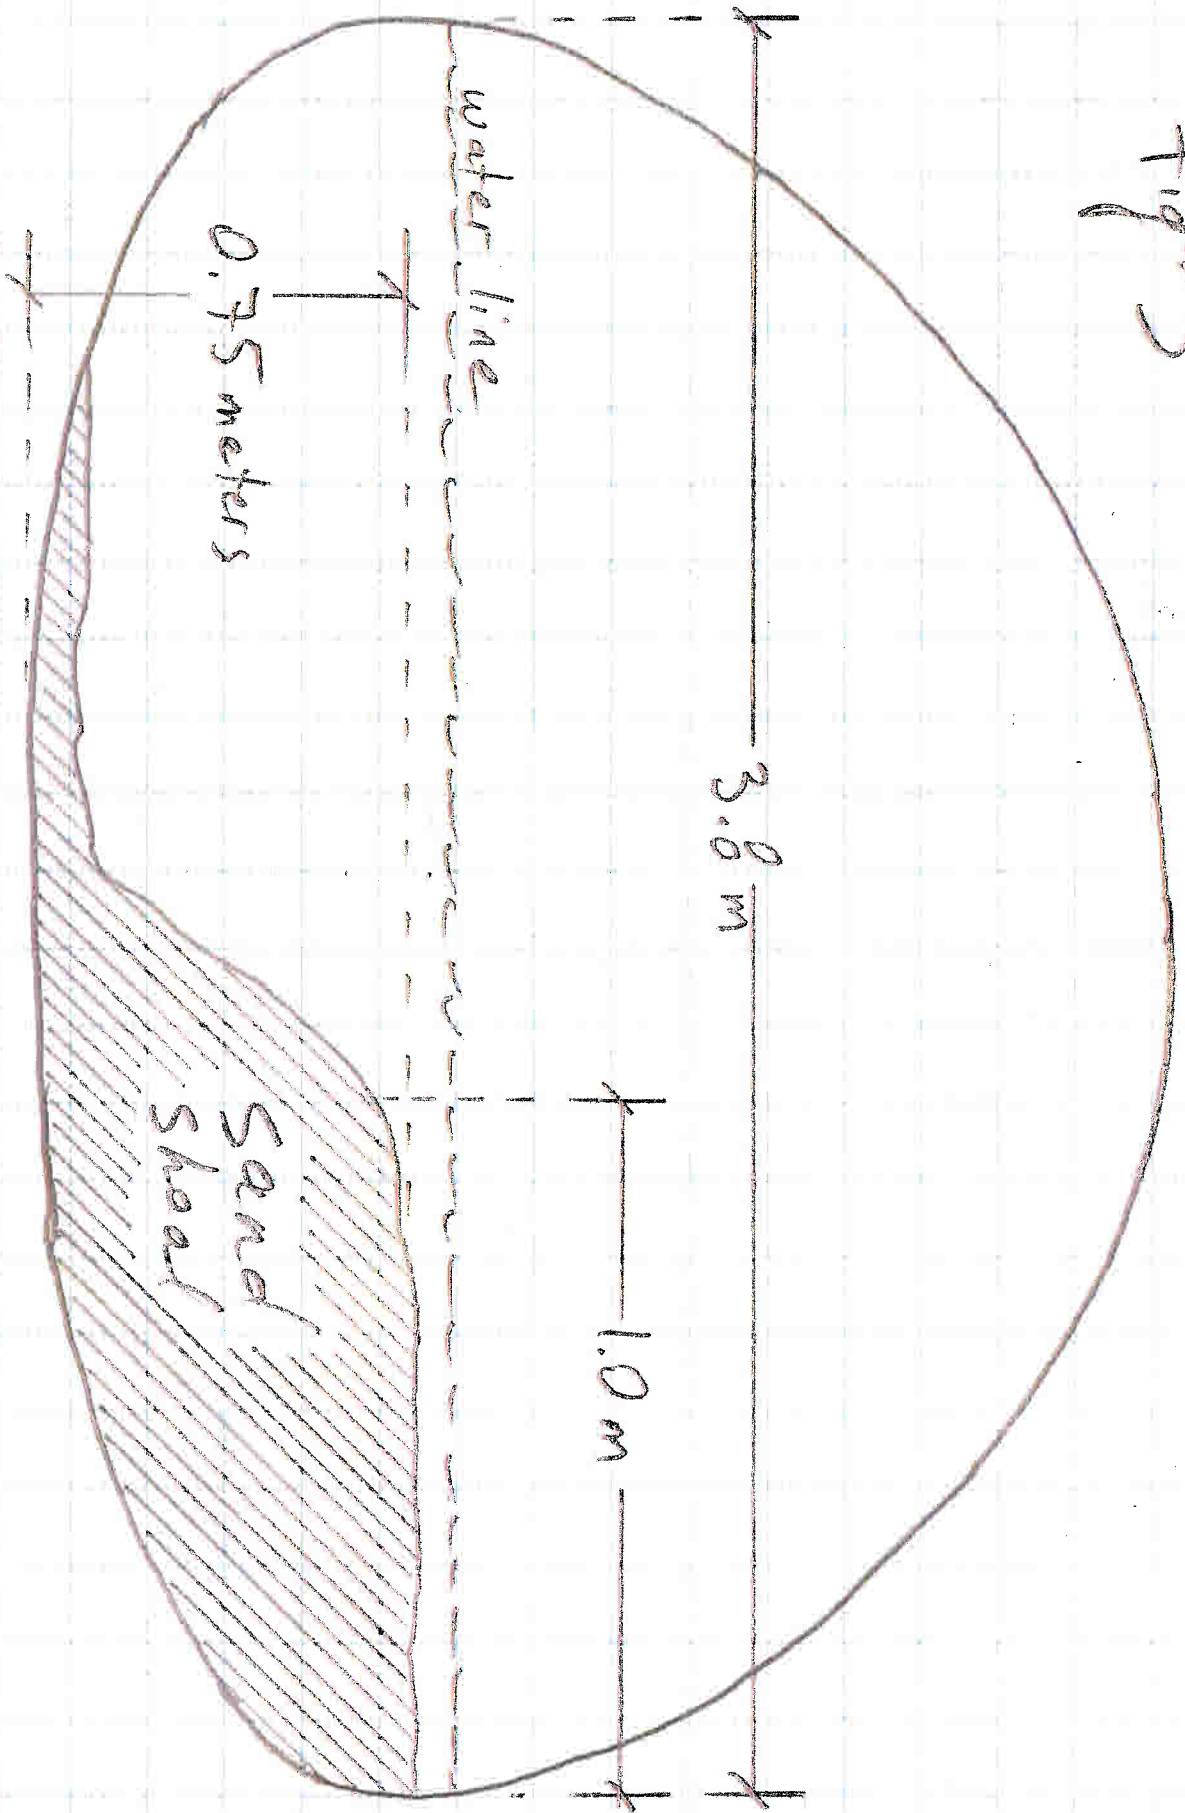
Fig #3

Profile of sand shoal in culvert (facing north)
at chainage 155 meters

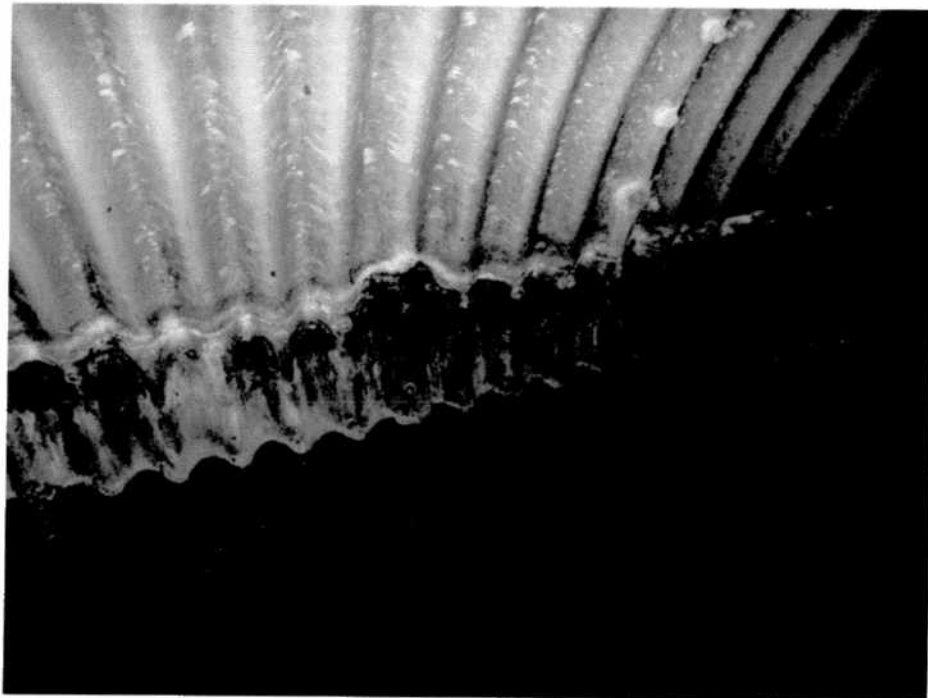
Photograph 4. Light to Moderate Corrosion of Culvert Wall ↑

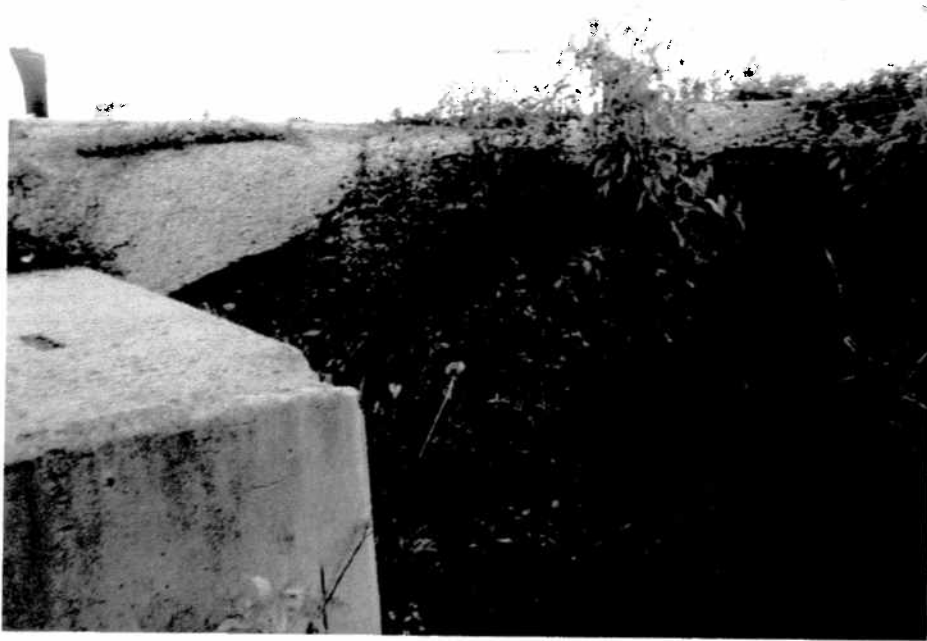
Photograph 5. Severe Erosion of Southeast Embankment ↑

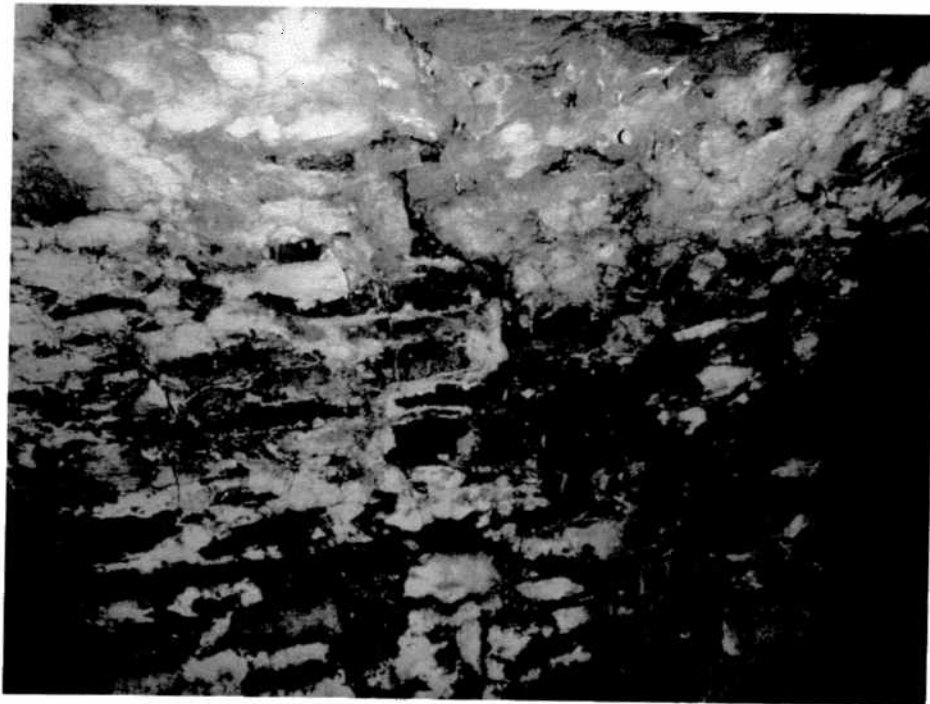
Photograph 4. Wide crack in West Wall ↑

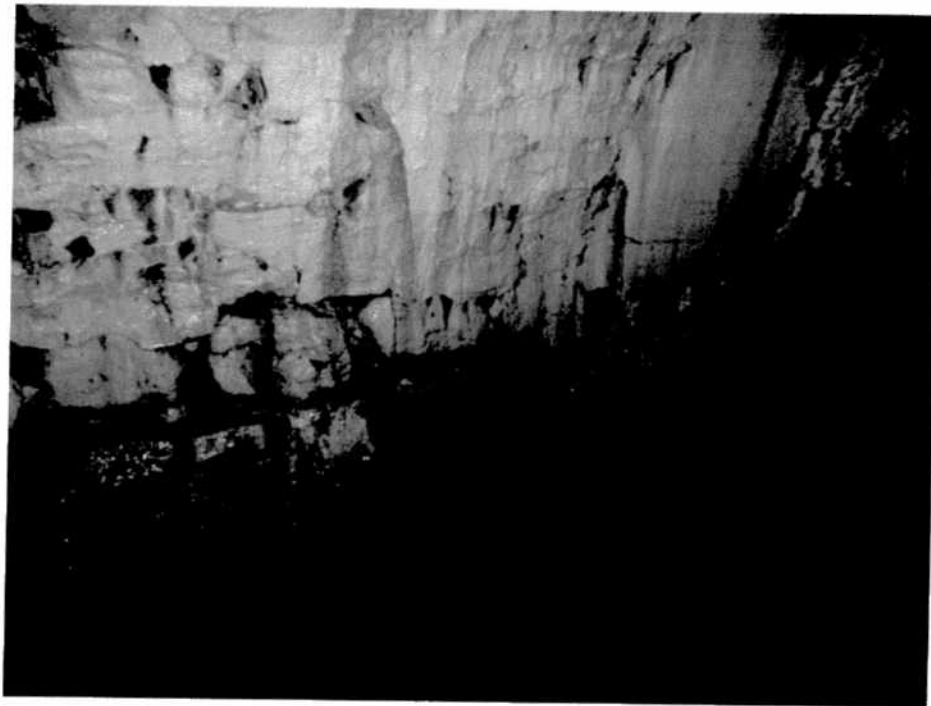
Photograph 6. Encrustation of Barrel ↑

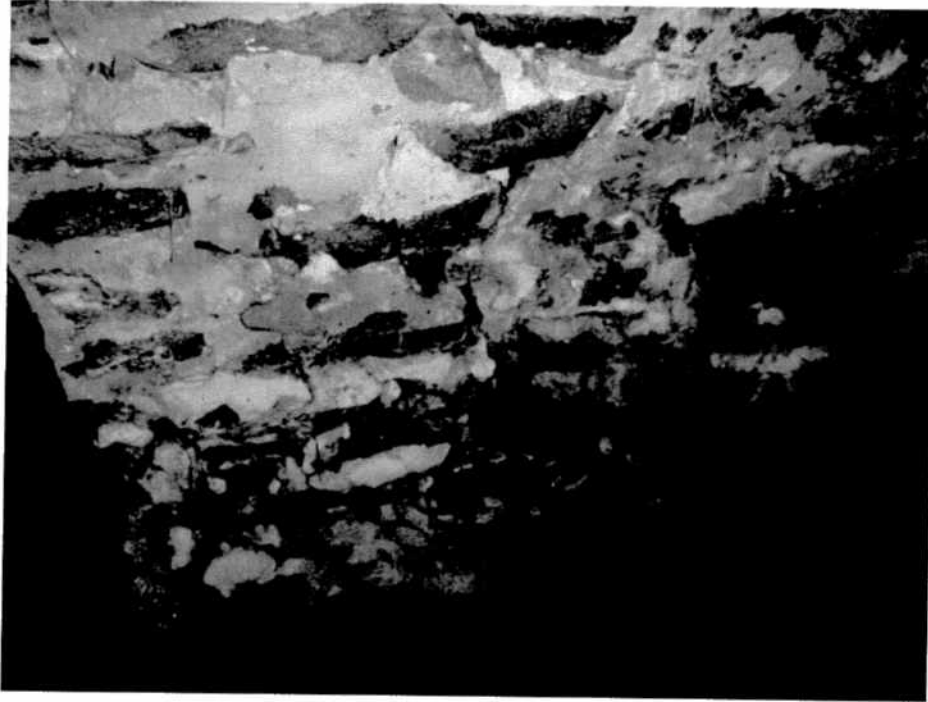
Photograph 7. Loss of Mortar from Stones!↑

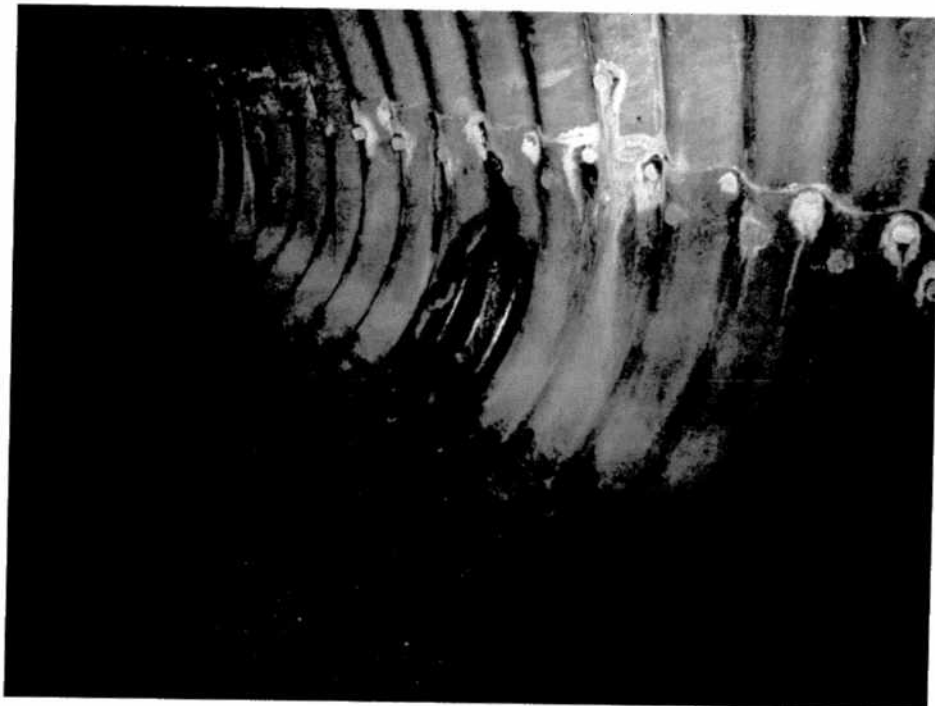
Photograph 2. Light Corrosion of Barrel ↑

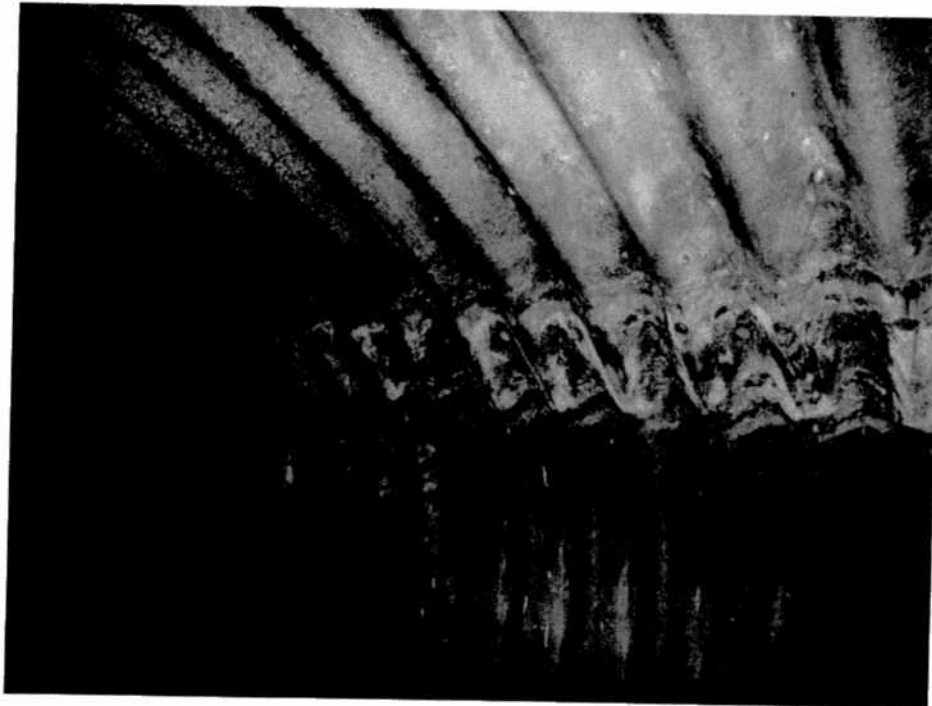
Photograph 2. Welded Patch on East Wall ↑

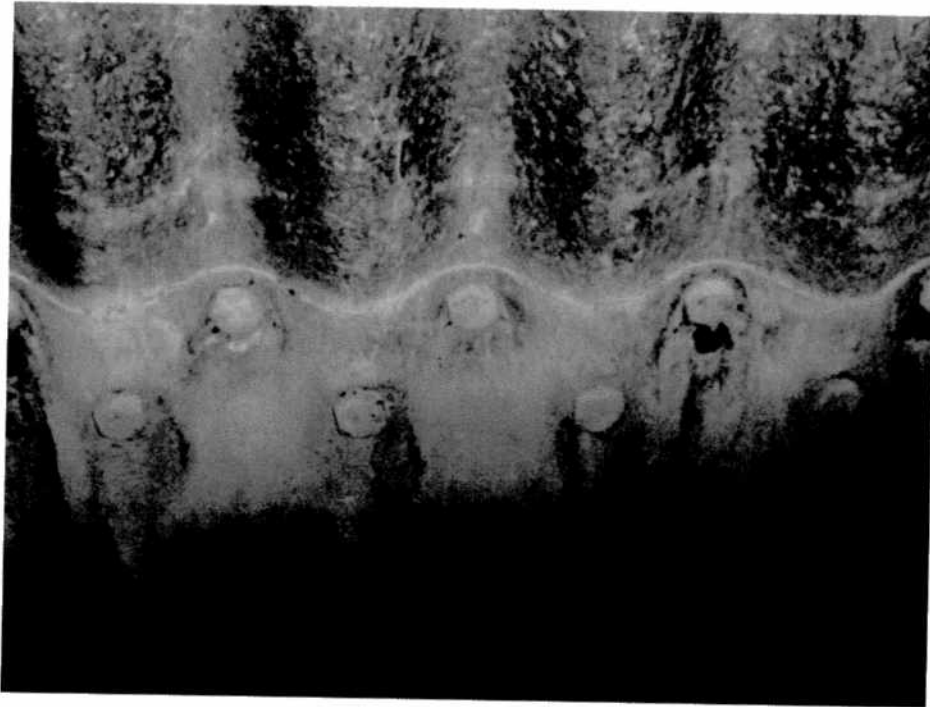
Photograph 3. Crack at Bolt Hole Location on West Culvert Wall↑

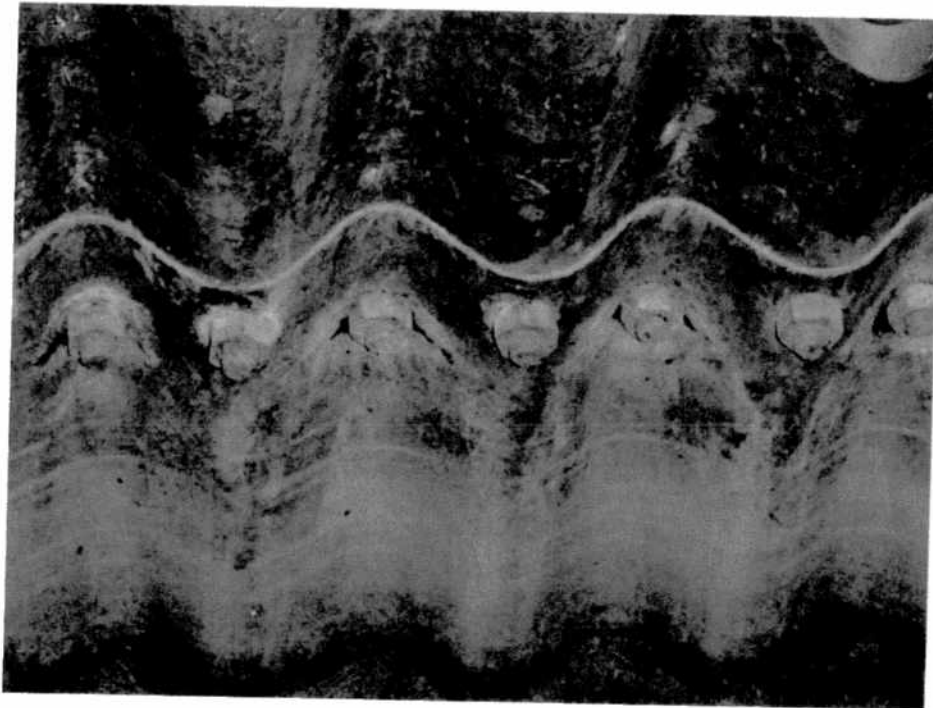
Photograph 2. Crack at Bolt Hole Location on West Culvert Wall ↑

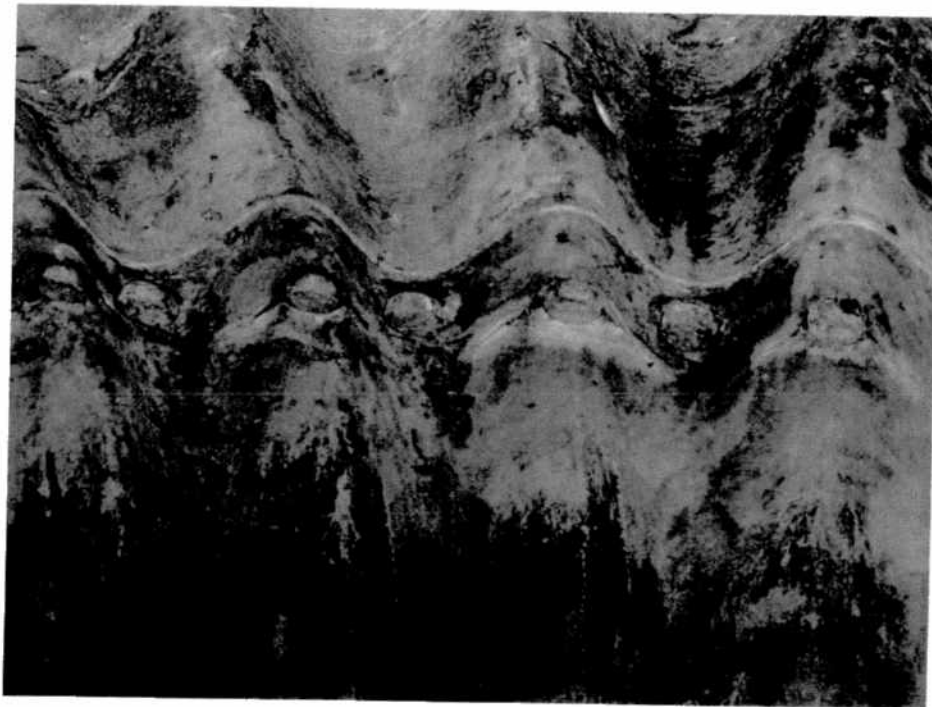
Photograph 4. Crack at Bolt Hole Location in Culvert Wall ↑

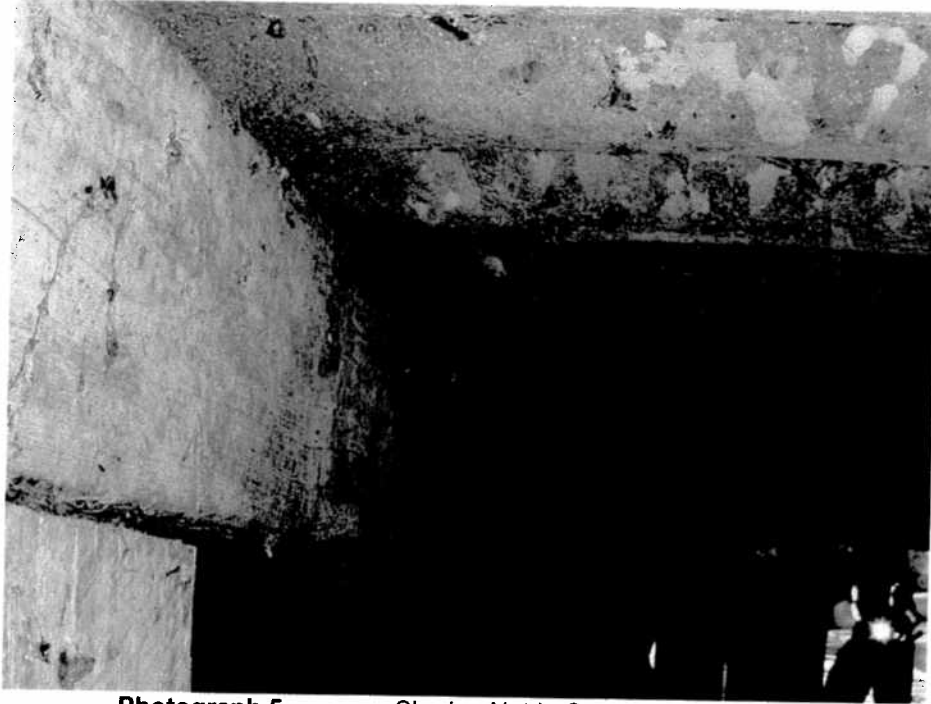
Photograph 5. Shoring Not in Contact with Barrel ↑

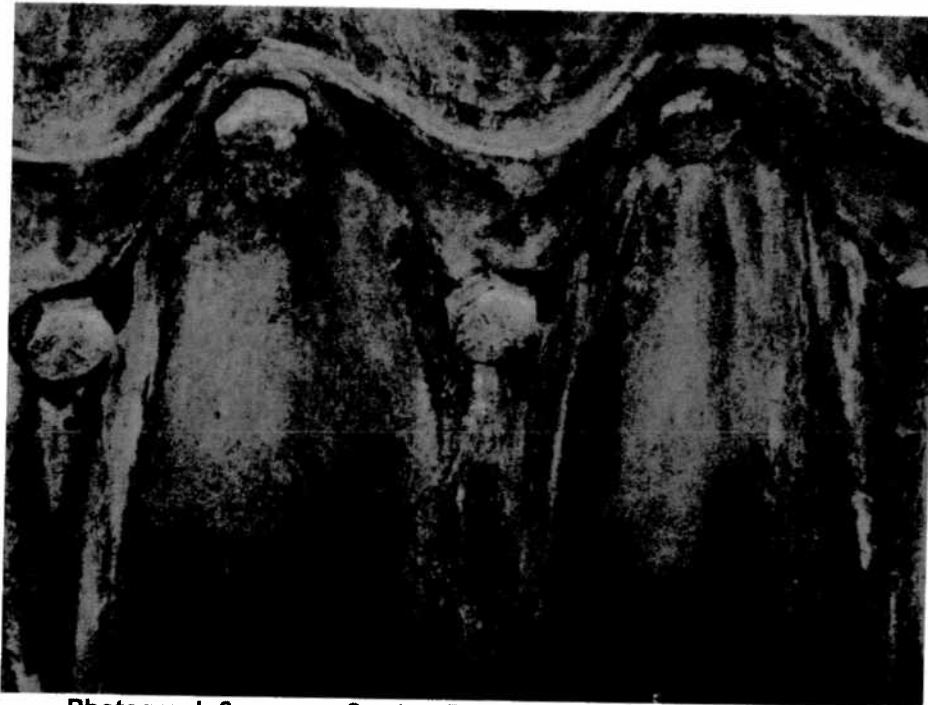
Photograph 6. Crack at Bolt Hole Location in Culvert Wall ↑

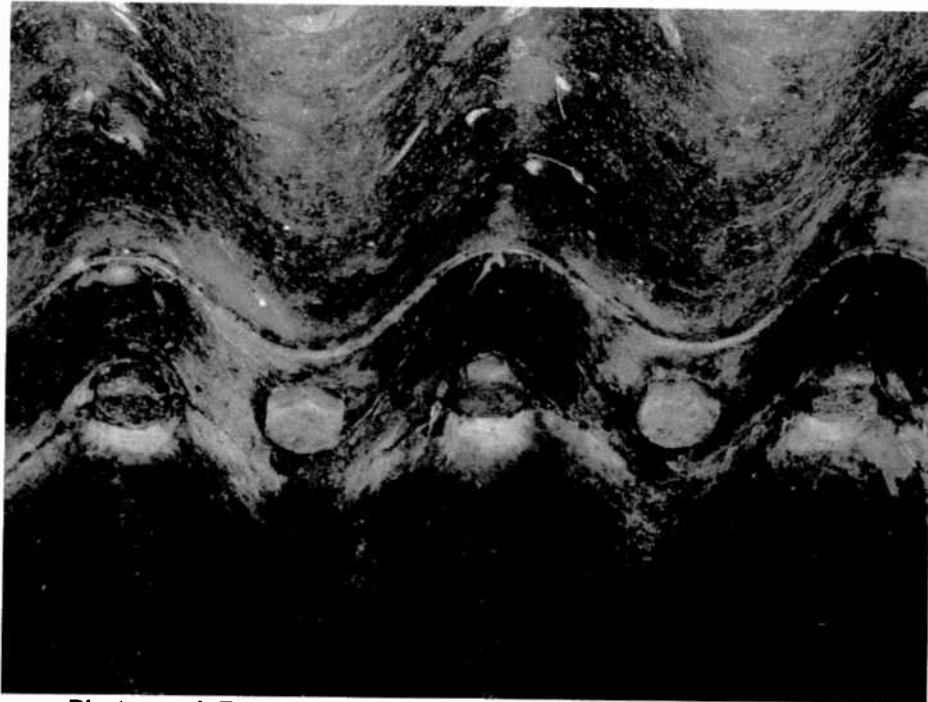
Photograph 7. Crack at Bolt Hole Location in Culvert Wall ↑

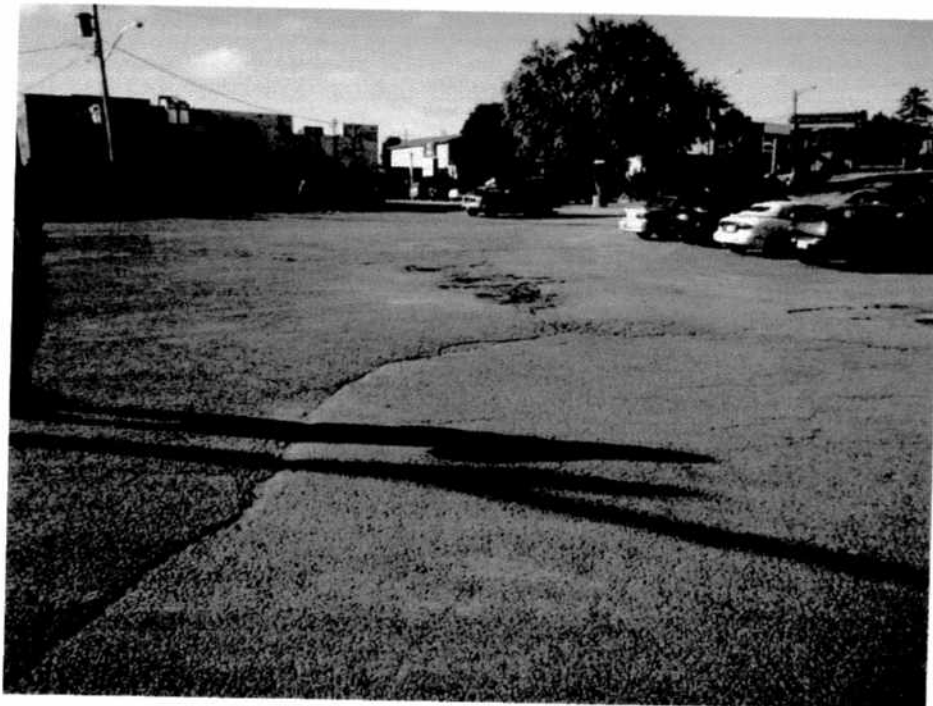
Photograph 2. Asphalt Over Culvert ↑

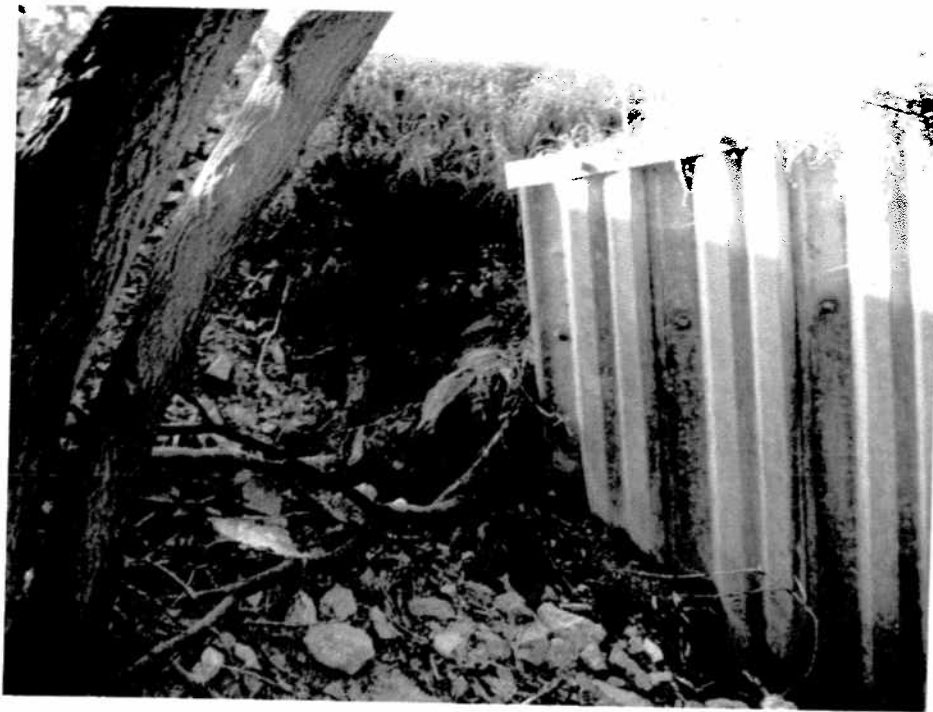
Photograph 4. Minor to Moderate Erosion of Embankment in Northeast Quadrant ↑

- Restore embankment
