Township of Uxbridge and Region of Durham

Downtown Uxbridge Flood Reduction

Schedule 'C' Municipal Class Environmental Assessment

Environmental Study Report

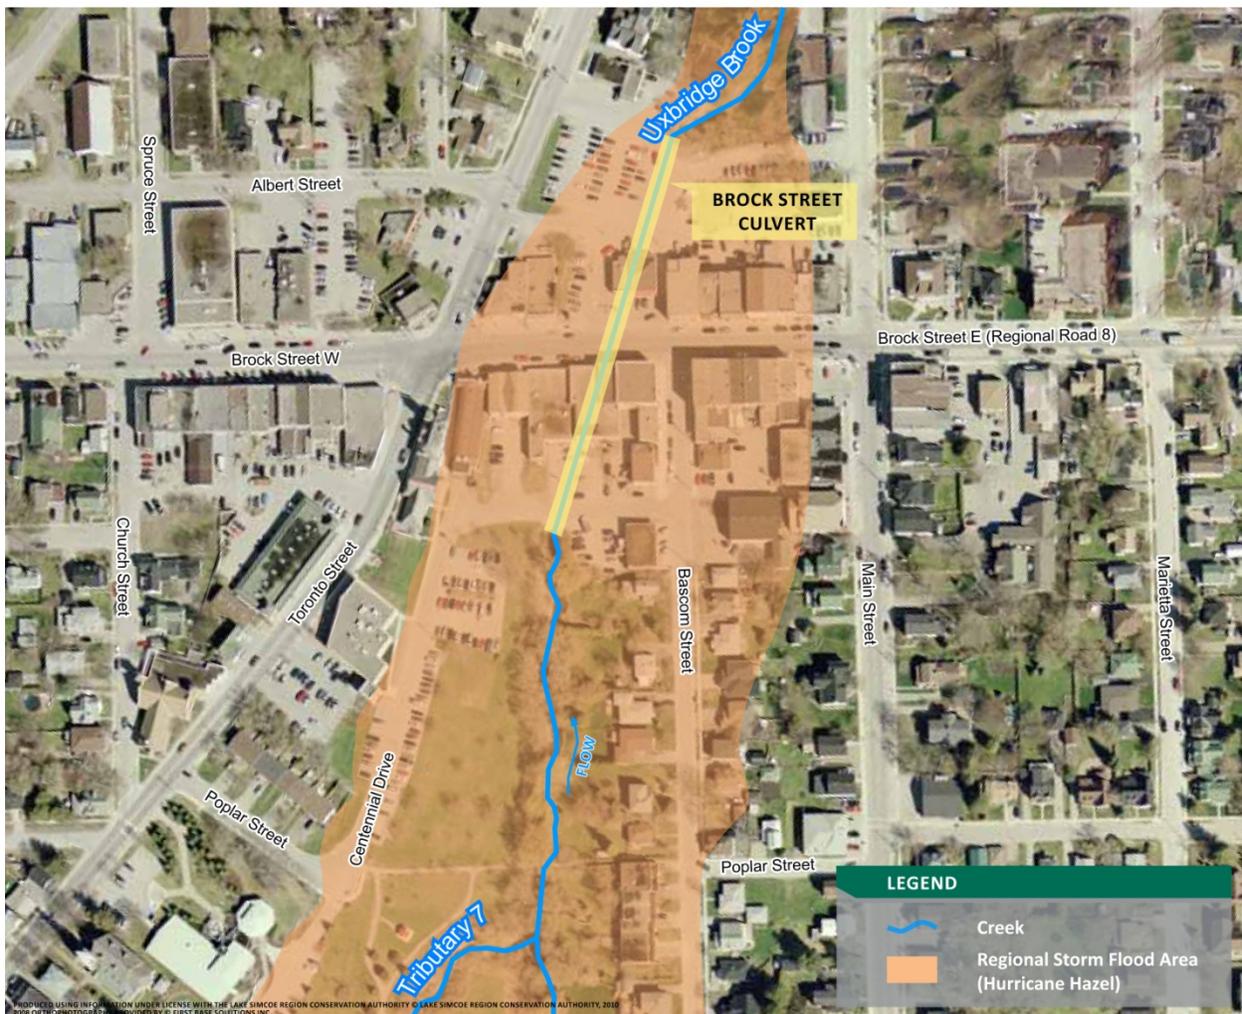
Figure 1. Extent of the Regional Storm Floodplain in downtown Uxbridge

A severe flood hazard exists under a Regional storm event (Hurricane Hazel) for the lands adjacent to the main branch of Uxbridge Brook, from Elgin Pond to just north of Brock Street (downtown Uxbridge). The flood hazard is due to the presence of a long culvert which encloses the creek from Centennial Drive to approximately 100 m north of Brock Street (**Figure 1**).

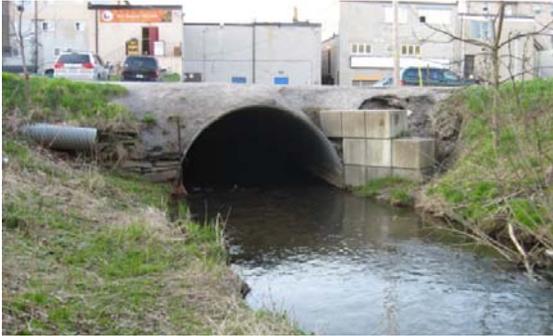
Section 1
Steel CSP arch with galvanized coating
3.4 m wide, 2.3 m high, 14.6 m long

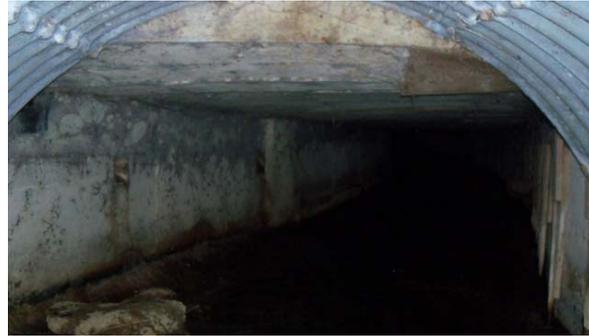
Section 2
Concrete culvert
3.1 to 3.3 m wide, 1.6 to 2.2 m high, 22.4 m long

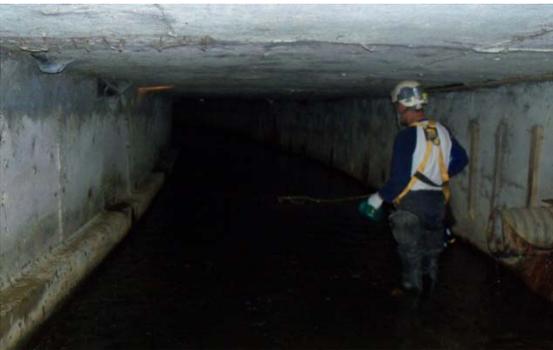
Section 3
Concrete culvert
5.5 m wide, 2.3 m high, 32 m long

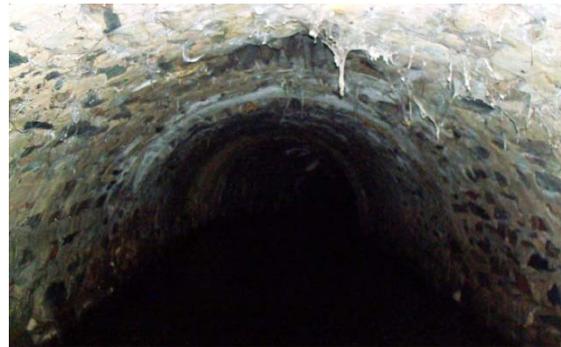
Section 4
Stone archway
3.5 m wide, 2.4 m high, 22.5 m long

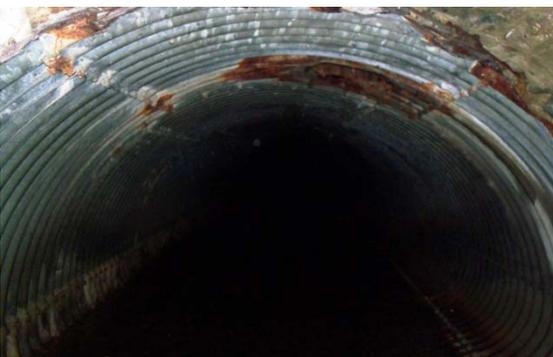
Section 5
Steel CSP arch with galvanized coating
3.3 m wide, 2.2 m high, 30.5 m long

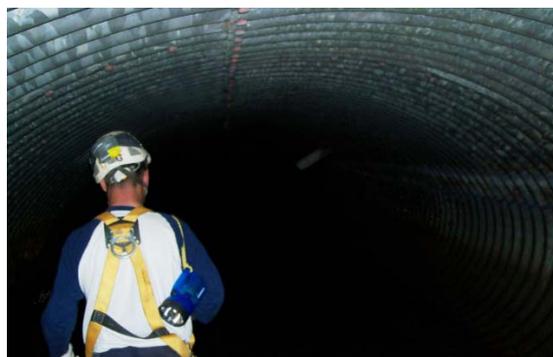
Section 6
Steel CSP with galvanized coating
3.7 to 4.0 m wide, 1.9 to 2.2 m high, 29 m long

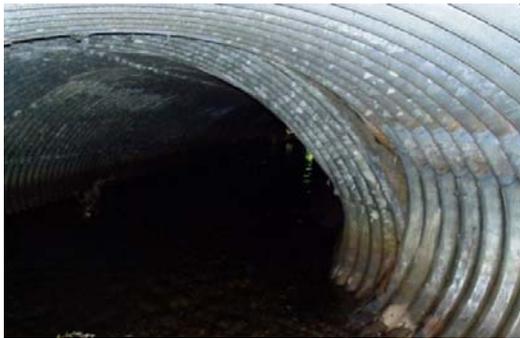
Section 7
Steel CSP arch with galvanized coating
3.8 m wide, 2.1 m high, 19.7 m long

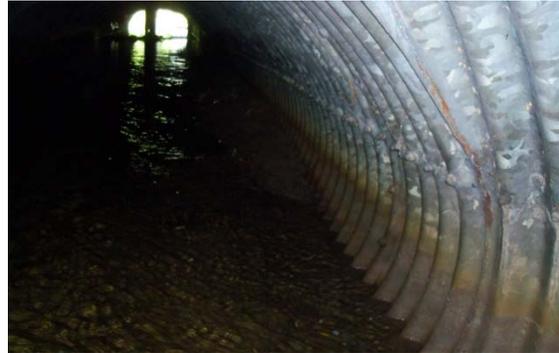
Section 8
Steel CSP arch with galvanized coating
3.8 m wide, 2.1 m high, 10.3 m long

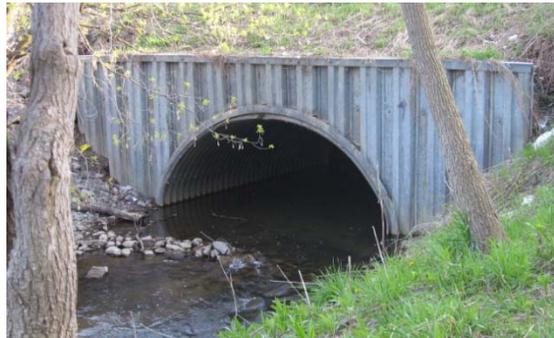
Section 9
Steel CSP arch with galvanized coating
3.8 m wide, 2.1 m high, 10 m long

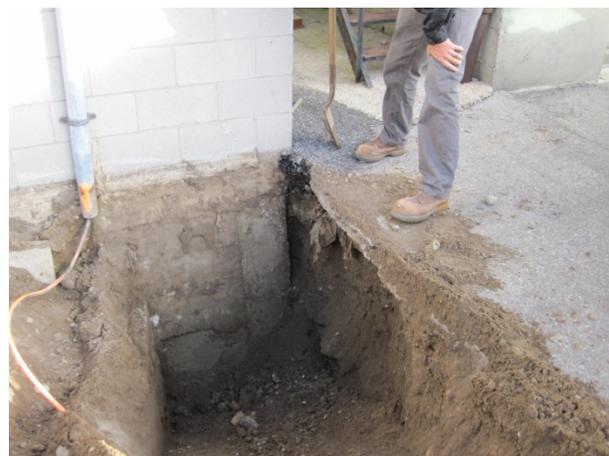
Figure 6. Exposure of building foundation at #34 Brock Street

On September 21, 2010, a visual inspection of the building foundations on the south side of Brock Street, above the culvert, was conducted to assess the extent to which the foundations were connected with the culvert. On October 12, 2010, a further visual inspection of the culvert in this location was conducted by exposing the foundation at the interface with the culvert (**Figure 6**).

From this inspection, it was clear that the building at #34 Brock Street (Youth Centre) is supported on the culvert chamber at least along the south end of the building. It is not certain that the alignment of the chamber matches that of the building as it extends to the north, however, it is a logical conclusion.

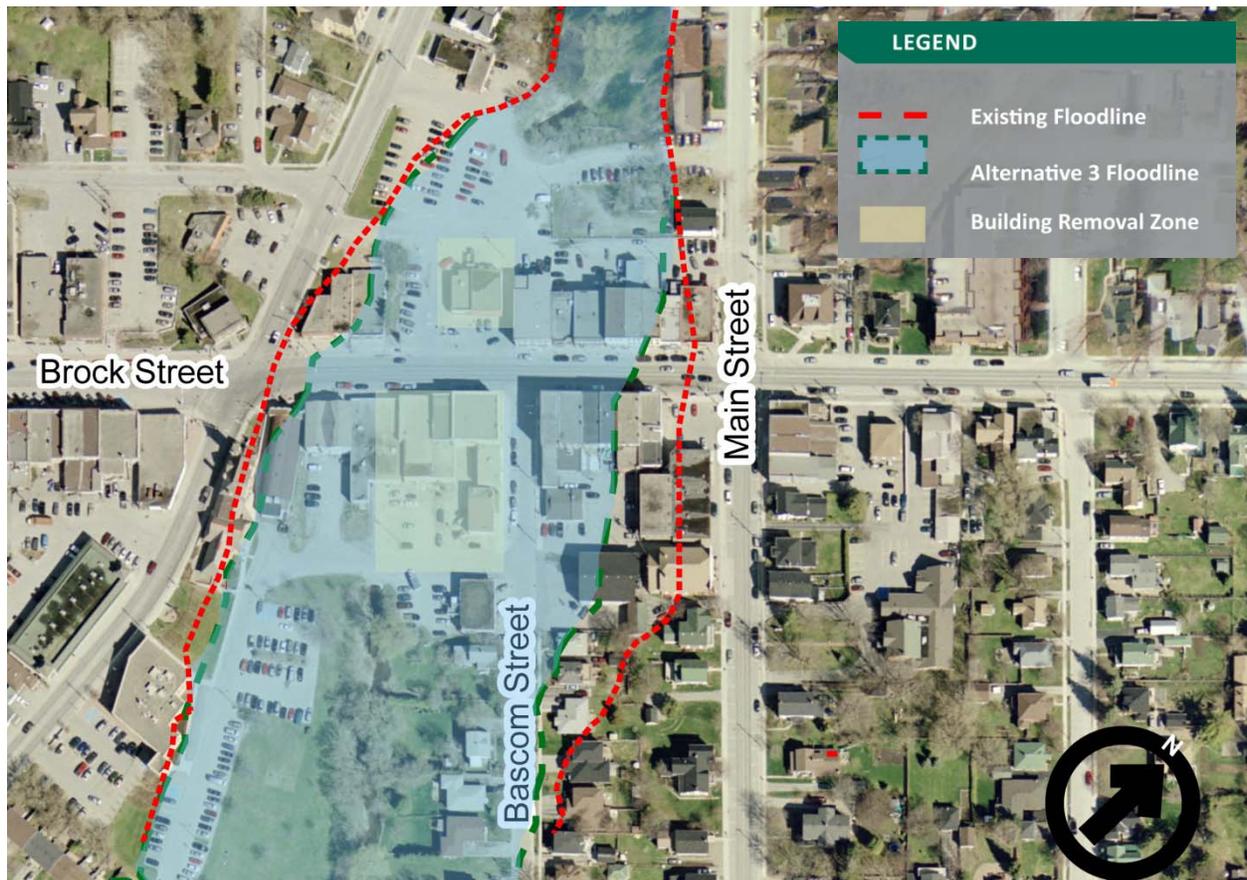
Figure 14. Modeled floodline resulting from Alternative Solution #3

The demolition of multiple buildings on the north and south sides of Brock Street to create an overland flow path for flood flows was investigated as a flood remediation measure. An array of widths for the overland flow path was analyzed ranging from 5 m to 25 m wide. The smallest opening would require removal of one municipally-owned building and the largest would require removal of all buildings between the Youth Centre Building and Getaway Travel (a total of seven buildings) in addition to the Mac’s Milk building on north side of Brock Street (**Figure 13**). The resultant floodlines from the creation of a 25 m wide overland flow path do not represent a substantial reduction in the floodplain (**Figure 14**).

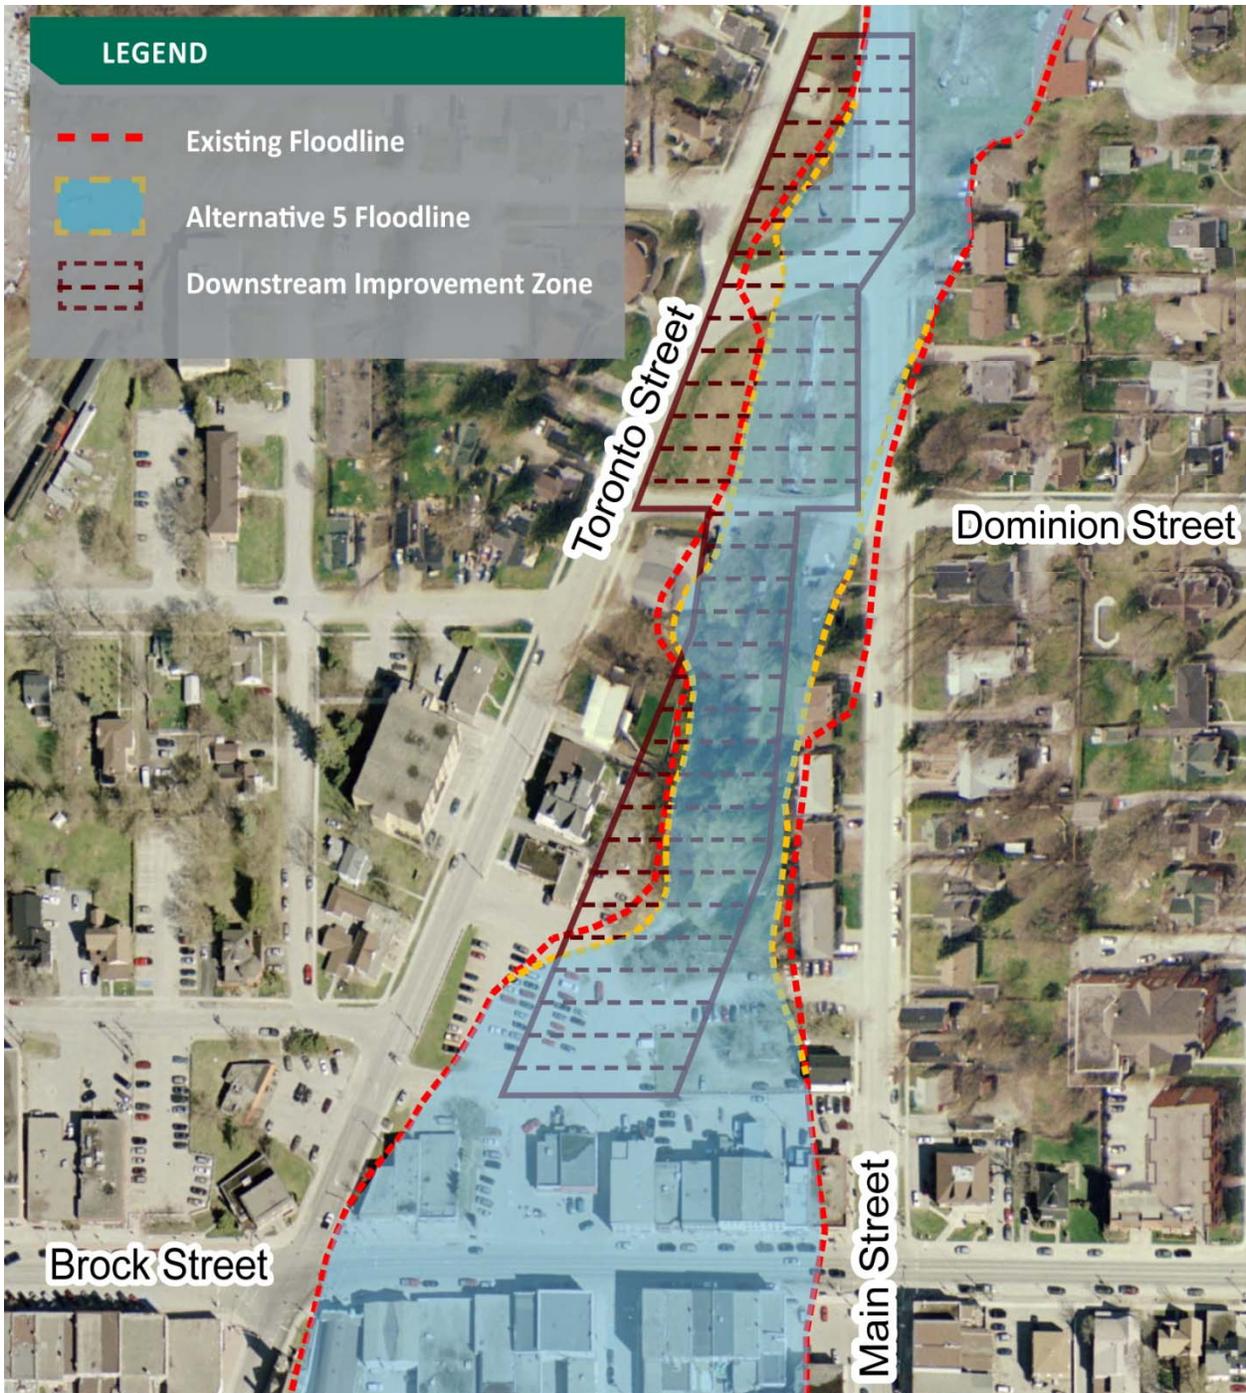
Figure 16. Modeled floodline resulting from Alternative Solution #5

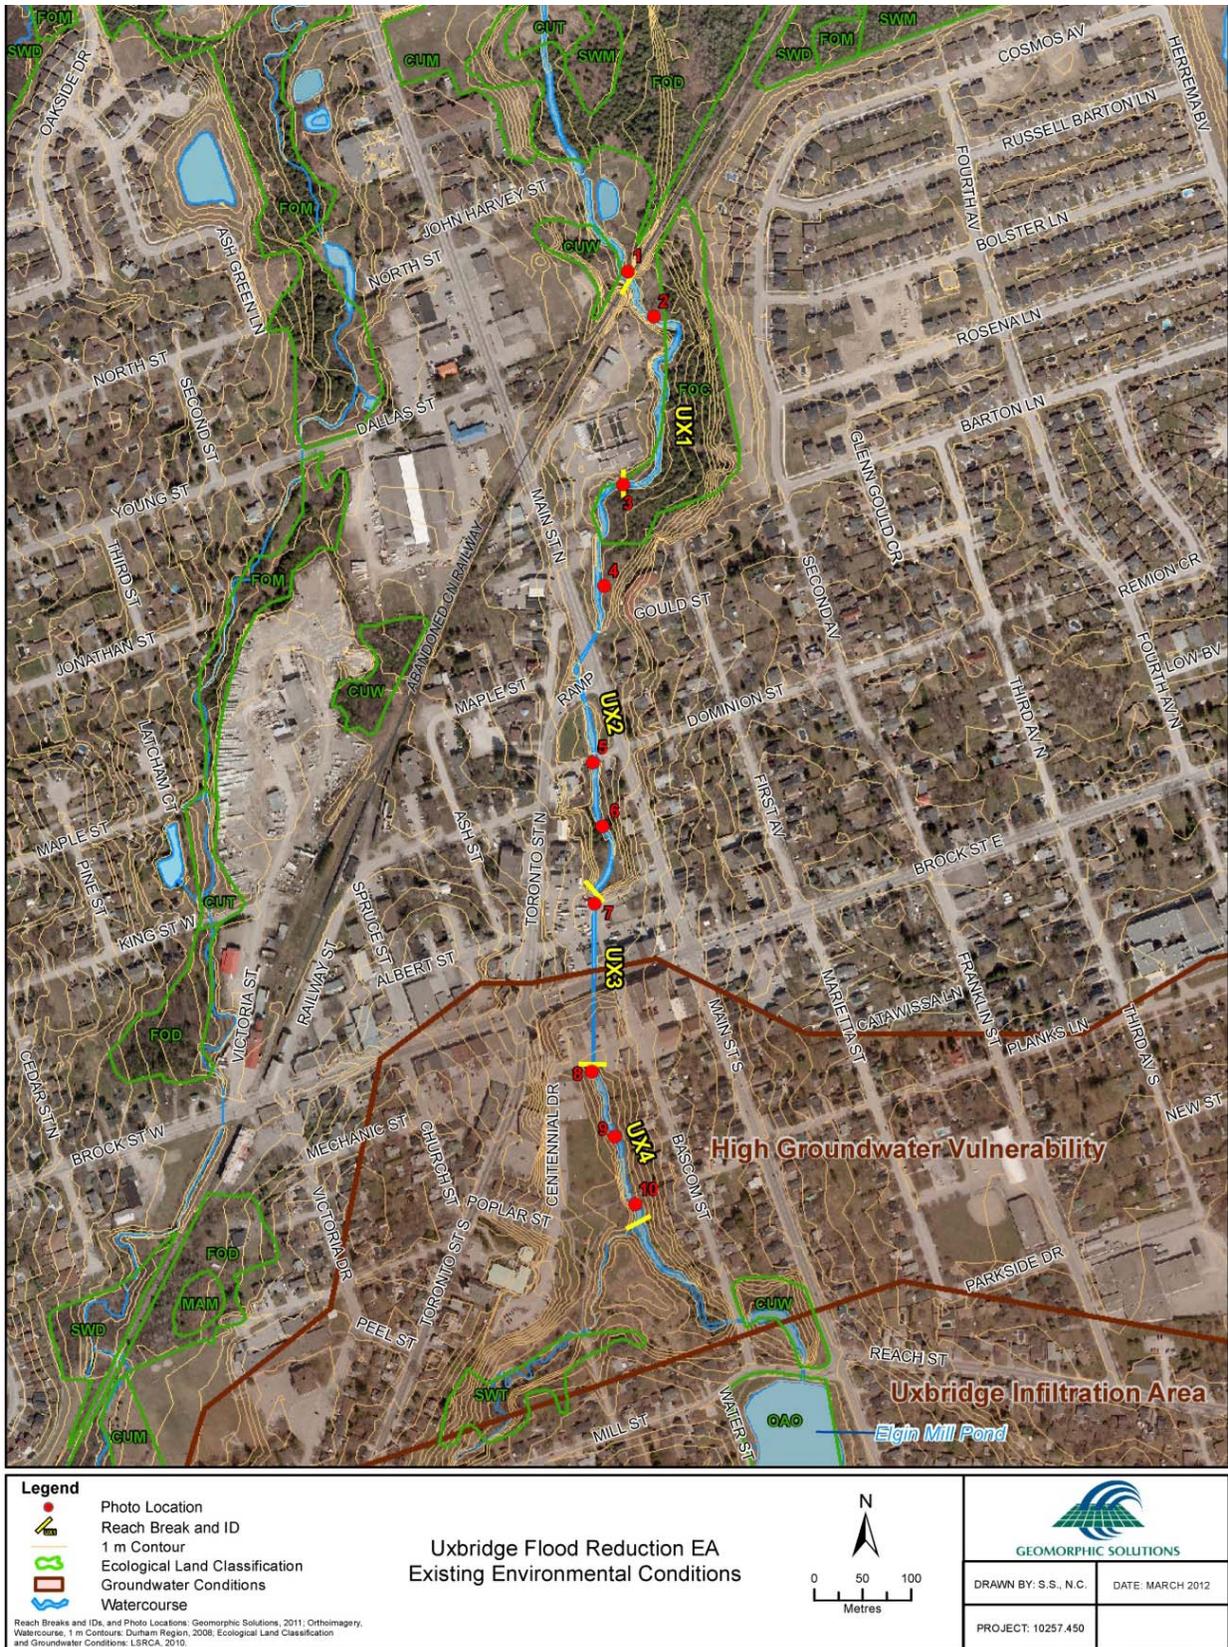
Figure 18. Reach delineation and existing environmental conditions along Uxbridge Brook

Reach delineation was completed utilizing a series of historical aerial photographs, topographic and surficial geology maps, and reports. Reach delineation is typically based on changes in channel planform and active geomorphological processes, which are directly related to local surficial geology, gradient, hydrology, land use, and riparian vegetation. Each reach is therefore expected to adjust in a generally uniform manner along its full length to changes in hydrology and sediment supply, as well as other modifying factors. Four reaches were delineated within the study area and were subsequently verified in the field (**Figure 18**). The gradient, channel sinuosity, and length of each reach were determined using a 2008 ortho-photograph provided by the Region of Durham and are summarized in **Table 5**.

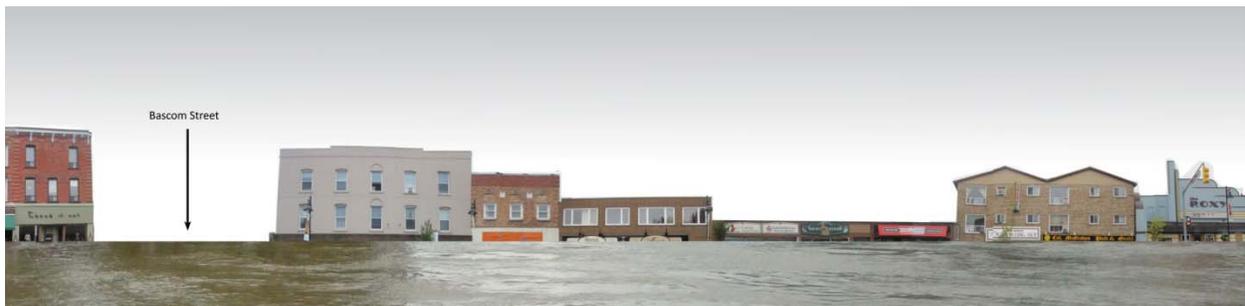
Figure 21. Illustration of modeled water depth on Brock Street during a Regional storm event

Figure 20 illustrates that the majority of buildings and streets are vulnerable to flooding in the downtown area for storm events greater than the 100-year storm. Under a Regional storm event, flooding on Brock Street is modeled to be as deep as 2.3 m. An illustration of the modeled water depth on Brock Street during a Regional event is provided as **Figure 21**.

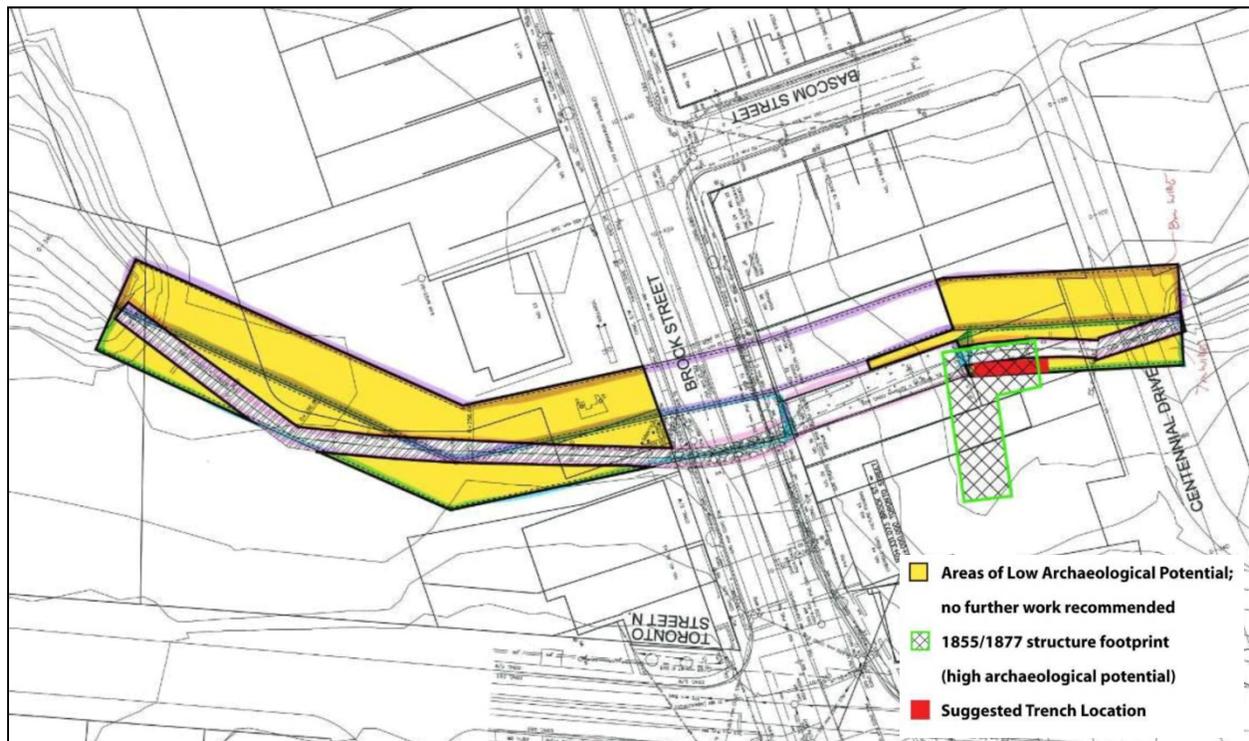
Areas identified as having been subjected to deep and extensive disturbance include the footprints of existing structures (30-34 Brock Street), the existing paved roadway (Brock Street), and the limits of the existing culvert installations (**Figure 23**).

Figure 23. Areas of archaeological potential

A review of historic maps of downtown Uxbridge has indicated that the footprint of an important 19th century structure that is likely tied to the beginnings of settlement in Uxbridge is partially encompassed within the study area. Within an urban context, deeply buried archaeological resources can remain sealed and, thus, entirely preserved, where extensive excavation activities have not occurred. Since there is no conclusive evidence of deep and extensive ground disturbance and the complete removal of archaeological potential within the remainder of the footprint of the structure first depicted in the 1855 map, this area is therefore recommended to undergo Stage 2 archaeological assessment (refer to **Figure 23**). A Stage 2 archaeological assessment is not recommended in any other location.

1. No further assessment is required in areas of low archaeological potential shown on **Figure 23**.
2. The footprint of the structure identified on **Figure 23** should be subjected to a Stage 2 archaeological assessment, under the field supervision and monitoring of a licensed archaeologist, prior to any construction activities, in order to minimize impacts to heritage resources. This area should be surveyed employing deep, sub-surface excavation with a backhoe or equivalent heavy machinery in order to verify the presence of, and to assess, deeply buried archaeological resources. The trench should be excavated in order to obtain sections and clear profiles. The suggested trench location is indicated on **Figure 23**. Should significant archaeological resources be encountered, additional background research or fieldwork may be required by the Ministry of Tourism, Culture and Sport (MTCS).
